Lessons Learned From Analyzing Tornado Damage

By TIMOTHY P. MARSHALL

(Reprinted from *The Tornado: Its Structure, Dynamics, Prediction, and Hazards*.
Geophysical Monograph 79, 1993 by the American Geophysical Union.)

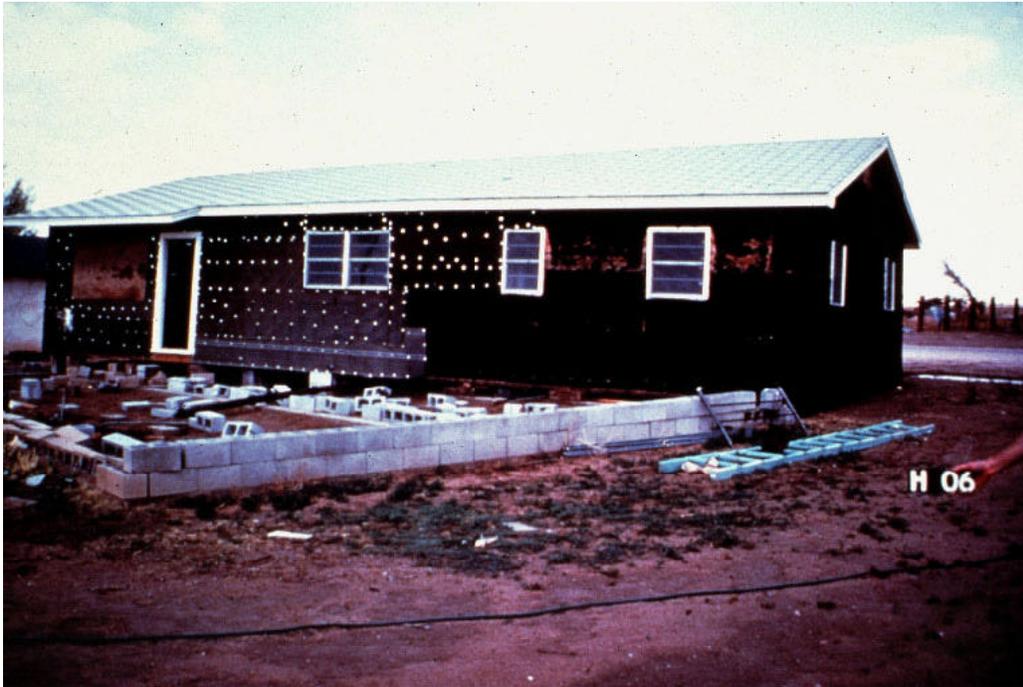
Figure 2. This premanufactured home was rotated Off its concrete block foundation during the Hereford, TX tornado. The house actually pivoted about the bathroom plumbing that was the only significant point of floor-to-ground anchorage. The rotation or "twist" of this object was best explained by the variations inherent within the structure rather than rotating wind currents. Note the lack of damage to roof shingles and felt underlayment along the walls indicative of relatively low wind velocities. Photo courtesy of IDR at Texas Tech University.

The fact that a tree, house, or object is twisted during a tornado does not indicate that the varying direction of the wind caused the damage. Although the primary wind flow in a tornado at the ground is rotational, the rotating wind field extends over a diameter much larger than the dimension of most objects. The width of an average house is much smaller than the diameter of an average tornado. Thus at any given instant, a building in the tornado path would receive winds that are approximately unidirectional. Tornado damage studies by Minor et al. [1977b] and Minor [1982] have indicated that twisted buildings are usually the result of variations in the strength of foundation anchorage, not the rotating winds. Often the bathroom plumbing provides the greatest anchorage of a house to the foundation, and the house will pivot around this point. McDonald [1971] concluded that a twisted house was more likely the result of different resistances in foundation anchorage rather than the spiraling winds (Figure 2). Such damage has been known to occur even in straight-line winds from severe thunderstorms.

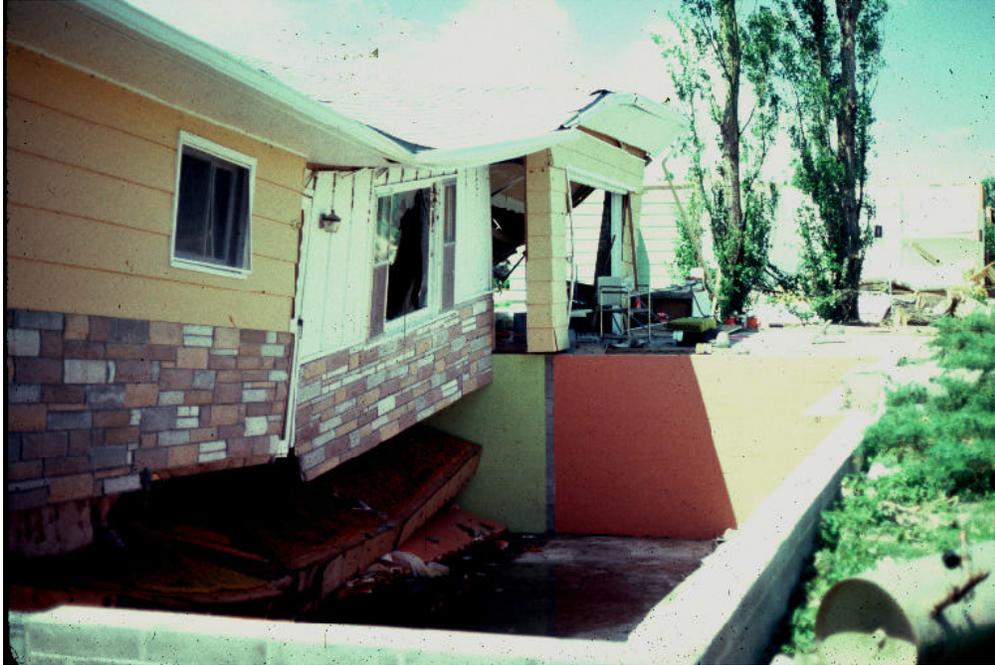
Figure 3. Lateral displacement of this unanchored home during the Grand Island, NE tornado caused the wooden floor structure to lose support and fall into the basement. Lack of damage to the surrounding trees and roof shingles indicated house movement occurred at wind velocities of probably less than 100 mph (161 km/h).

Inadequate wall/foundation anchorage has meant failure of large portions of structures. Conventional wood structures, especially rural dwellings, sometimes have little to no anchorage to their foundations. Minor [1981] has shown examples of unanchored buildings that have moved laterally off their foundations in strong winds. See Figure 3. Properly installed anchor bolts in slabs would help secure walls to the foundation and provide greater resistance against lateral movement.

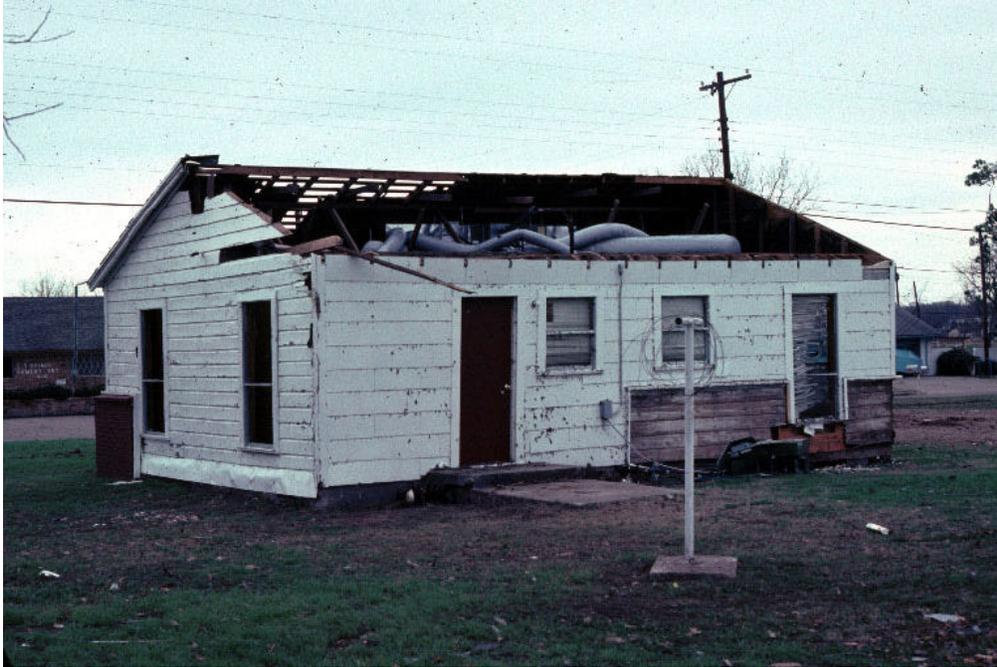
Figure 4. The roof on this house was not anchored very well and was uplifted during peripheral winds in the Mesquite, TX tornado on December 13, 1994. wind velocities of less than 100mph (161 km/h) can cause such residential damage.

Wooden roof joists/top plate and rafter/top plate connections are usually toenailed. Such connections typically fail in tension, causing large sections of the roof to become displaced (Figure 4). Properly installed straps or braces are needed to place fasteners in shear, not tension, in order to provide greater resistance against uplift (Figure 5). As wind velocities increase with height above the ground, roof systems usually experience strong wind uplift pressures. Conner et al. [1987] showed various illustrations in using straps and tie-downs in securing roofs to perimeter walls. Pull tests conducted by Canfield et al. [1991] have shown a dramatic increase in the strength of the rafter-top plate connection when metal rafter ties were used instead of simple toe nailing.

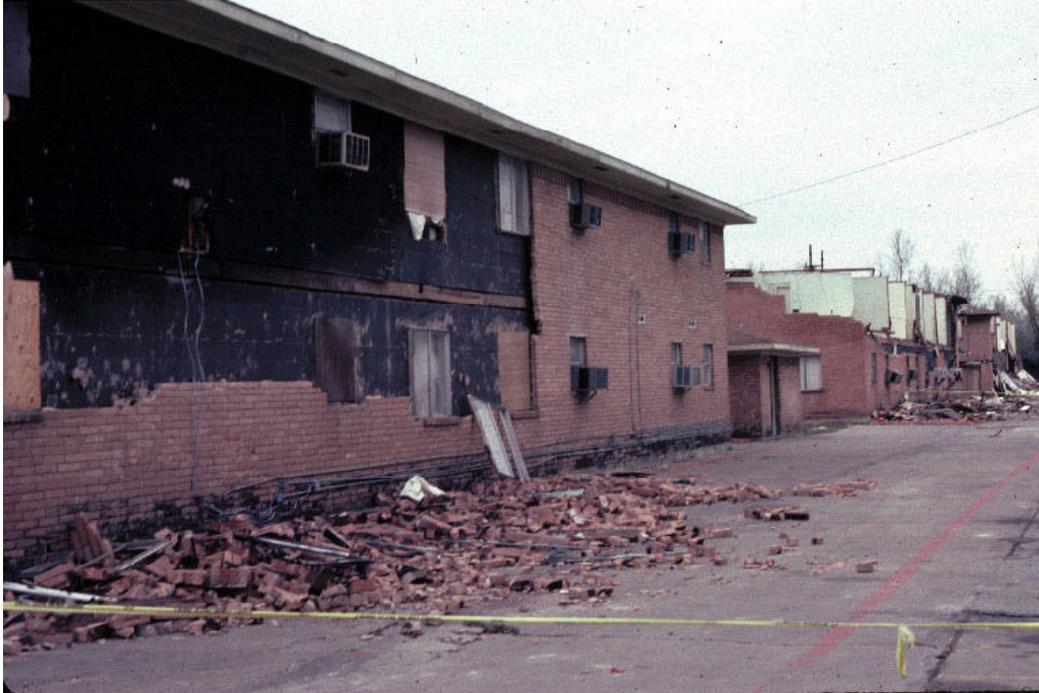
Figure 6. Damage to a two-story brick veneer wall in the Mesquite, TX tornado. There were no brick ties to anchor the wall to the wooden frame. The wall toppled on the leeward or "suction" side.

Absence of brick ties to secure masonry veneers has led to wall failures at relatively low wind velocities (Figure 6). Even when brick ties have been properly installed, corrosion and fatigue over time can reduce the performance of such ties.
